BOULDER COMMUNITY HOSPITAL

SUMMARY OF DECONSTRUCTION, STOCKPILE AND REUSE

CITY OF BOULDER

SEPTEMBER 2025

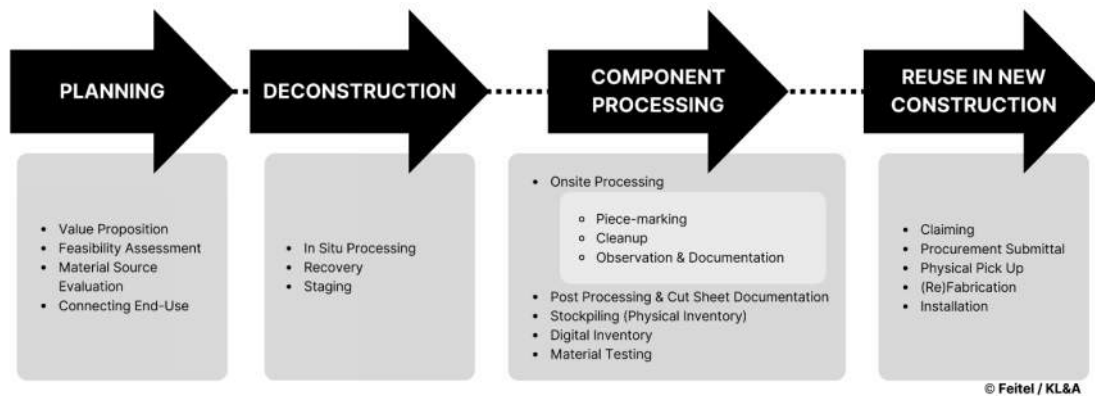
Figure 1: The general process and workflow for the deconstruction, recovery, and reuse of BCH steel.

See Figure 1 for the general process and workflow. The stockpile was closed August 2025, and all members were procured for reuse. Roughly 40 professionals engaged with the BCH stockpile and reviewed the available inventory. **21 new construction projects, all located in Colorado, reused the salvaged steel**, ranging from non-building structures and small-scale residential renovation projects to multi-story institutional projects, see Figure 2.

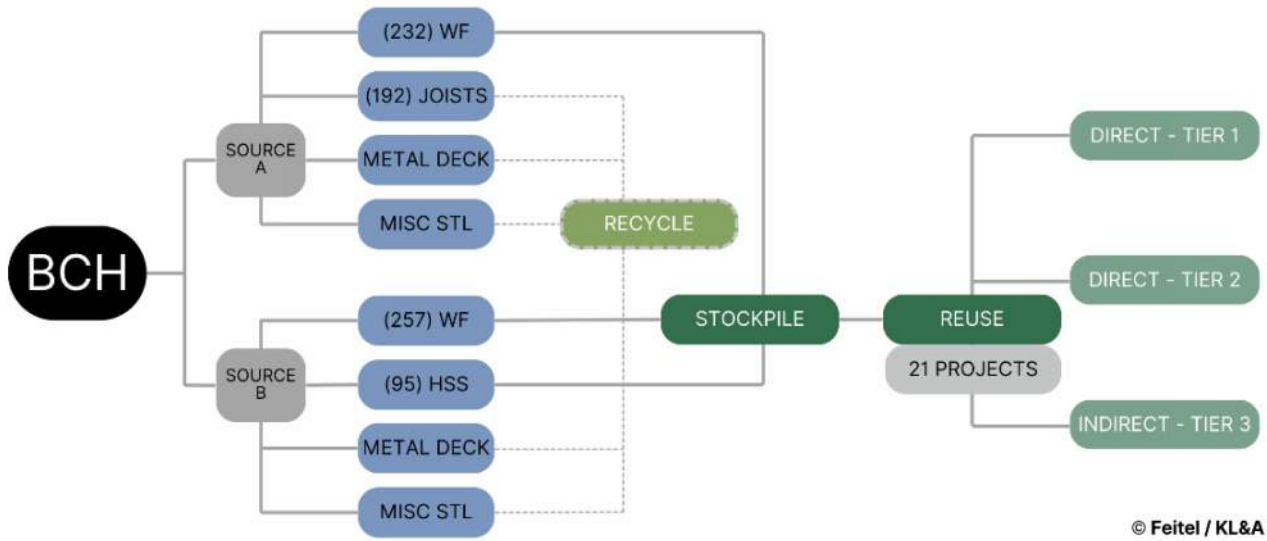
Figure 3: Material map of the steel from source to reuse applications.

See Figure 3 and 4 for a material map, detailing the quantity of pieces sourced, recovered, and reused. Direct Tier 1 represents structural reuse in applications that require steel due to structural conditions. The majority of these buildings are multi-story institutional buildings owned by the City of Boulder. Direct Tier 2 represents

structural reuse in smaller-scale applications that do not necessarily require steel, such as single-family residential buildings, shade structures, and retaining walls. Indirect Tier 3 represents non-structural reuse (downgrading functional use of the steel) in applications such as storage racks, art installations, and educational uses.

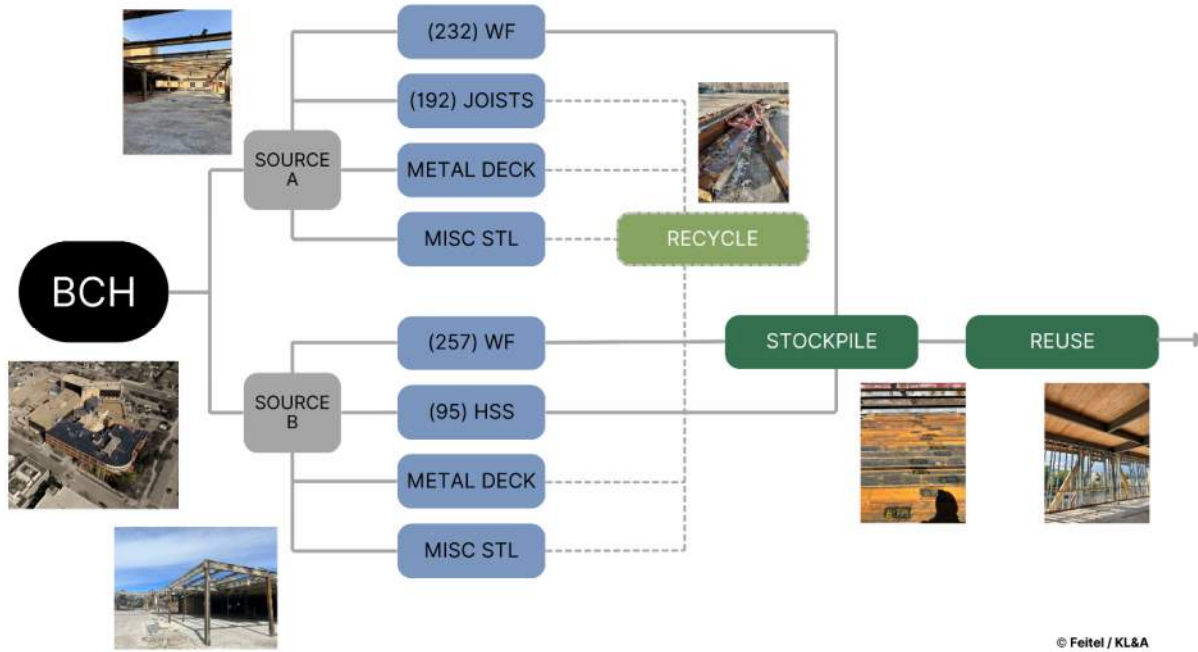
Figure 4A: Exploded material map of the steel source, including piece quantities.

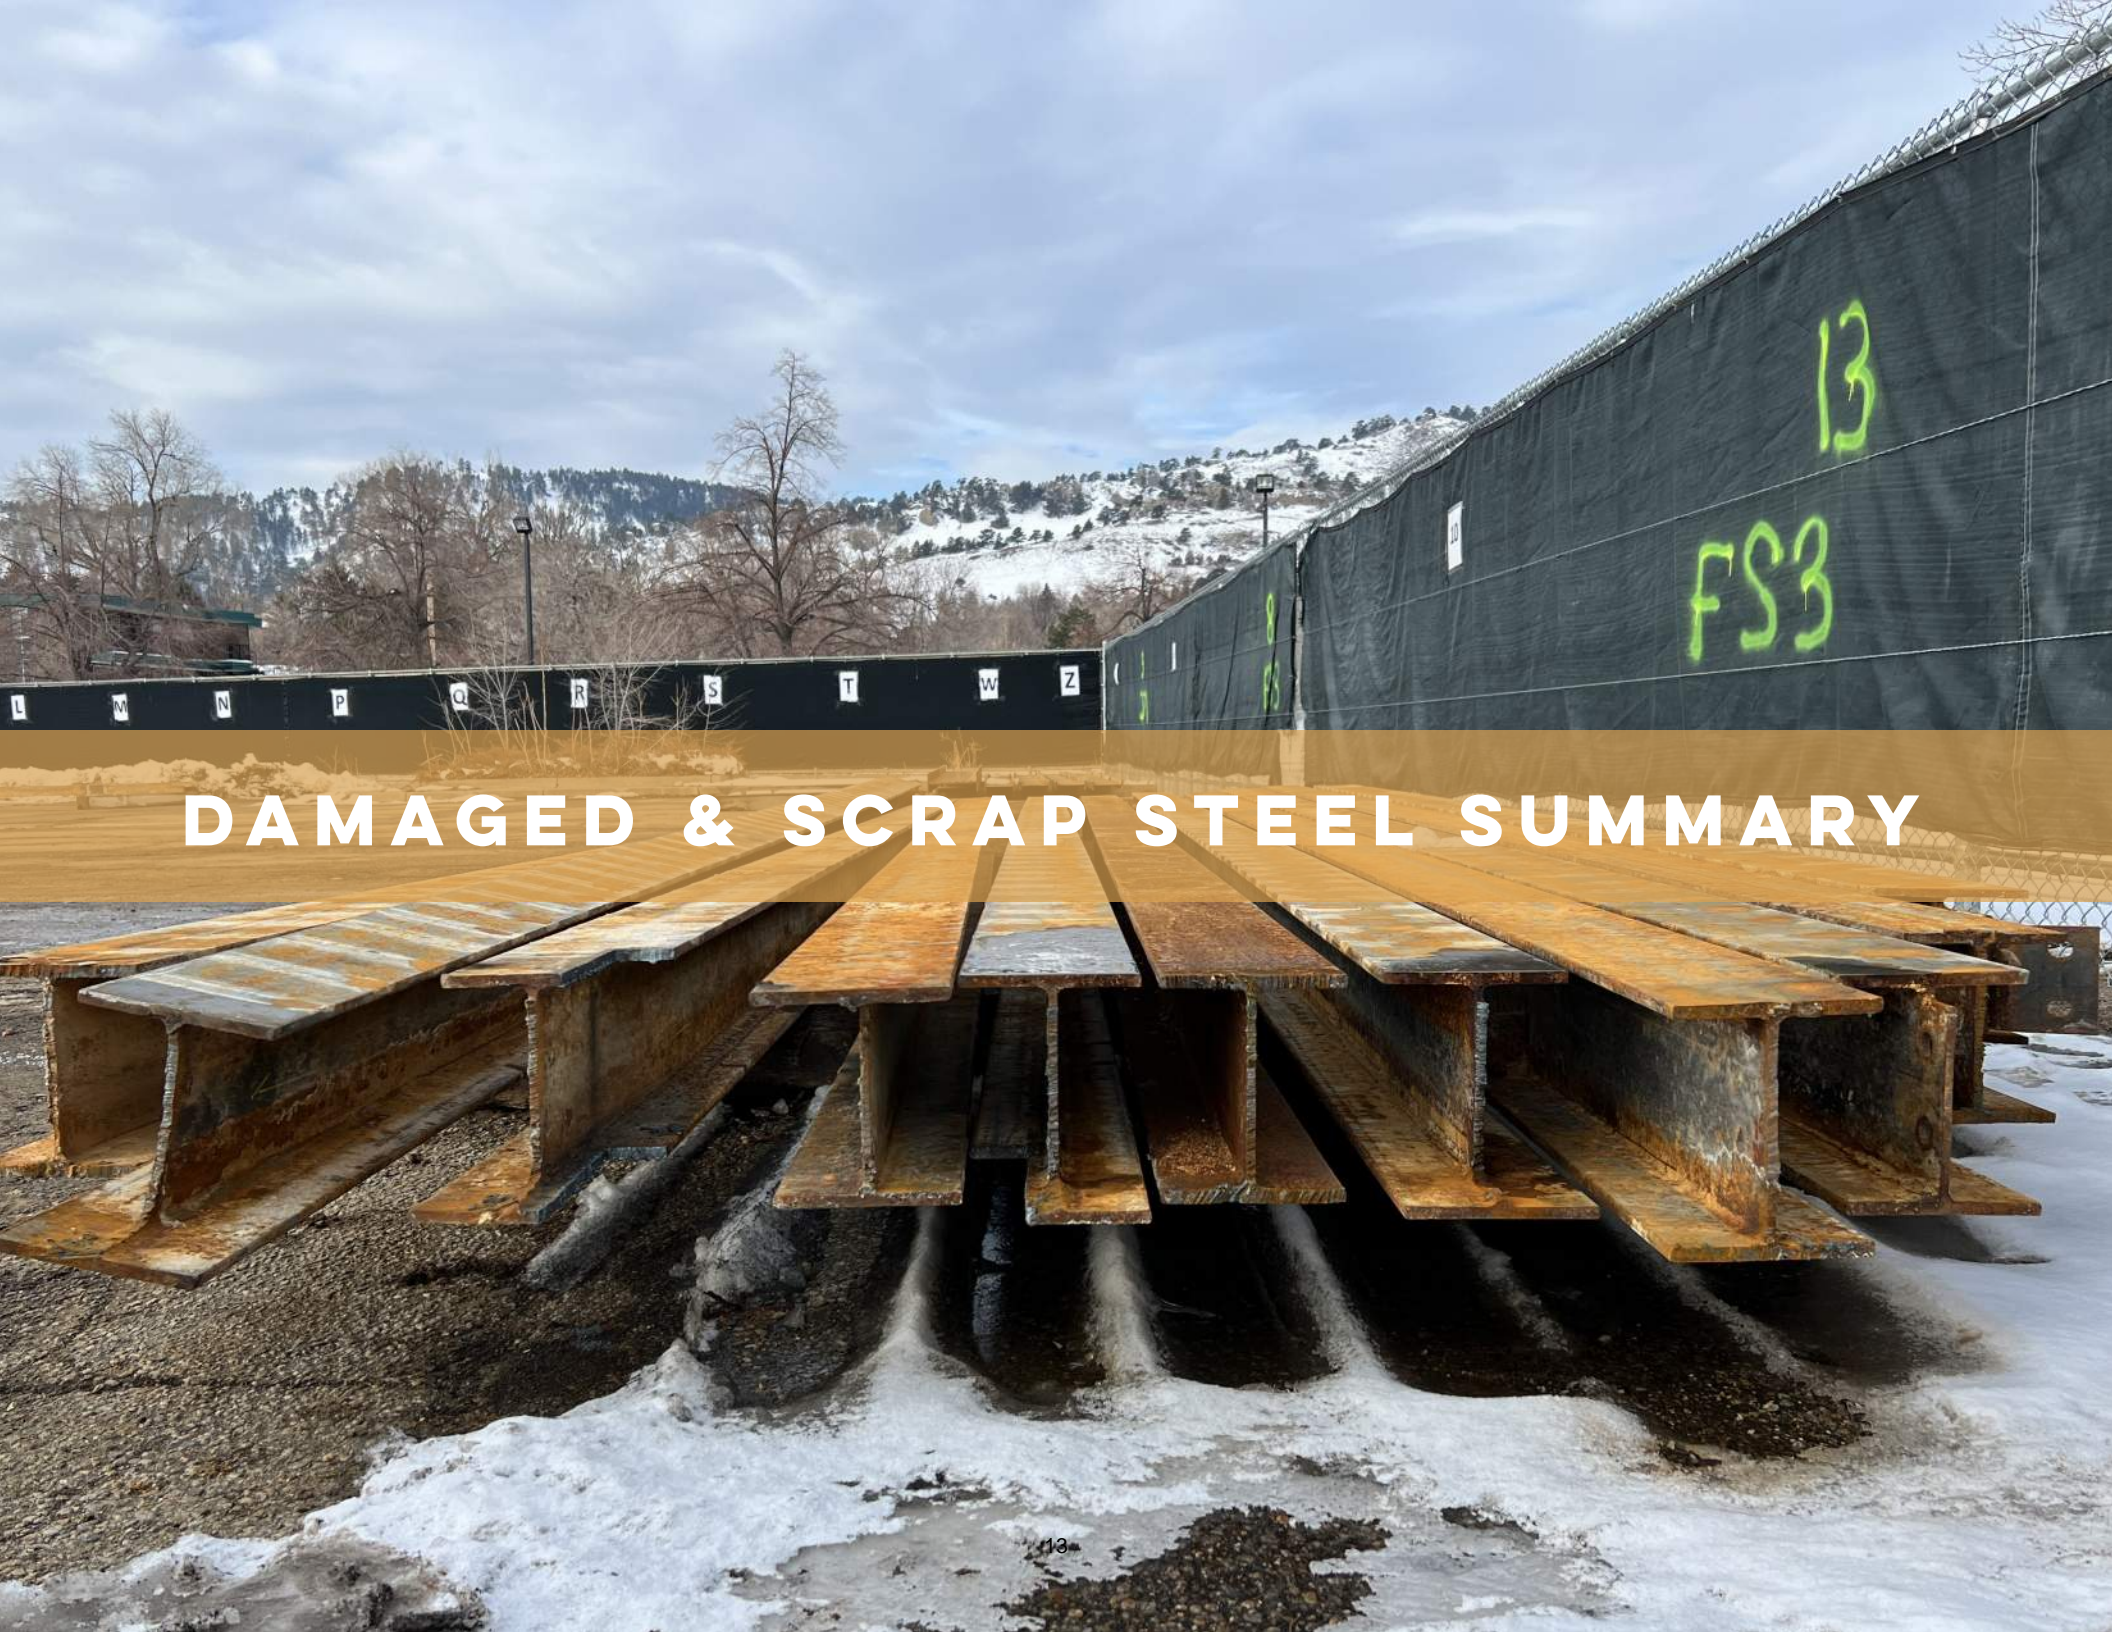
DAMAGED & SCRAP STEEL SUMMARY

Recovered and Reused Steel Inventory: **Damaged & Scrap Piece Tracking**

These are all wide flange members.

These numbers do not include all steel scrap and misc metals that may have been recycled.
