FEMA 308

REPAIR OF EARTHQUAKE DAMAGED CONCRETE AND MASONRY WALL BUILDINGS

The Applied Technology Council

1998

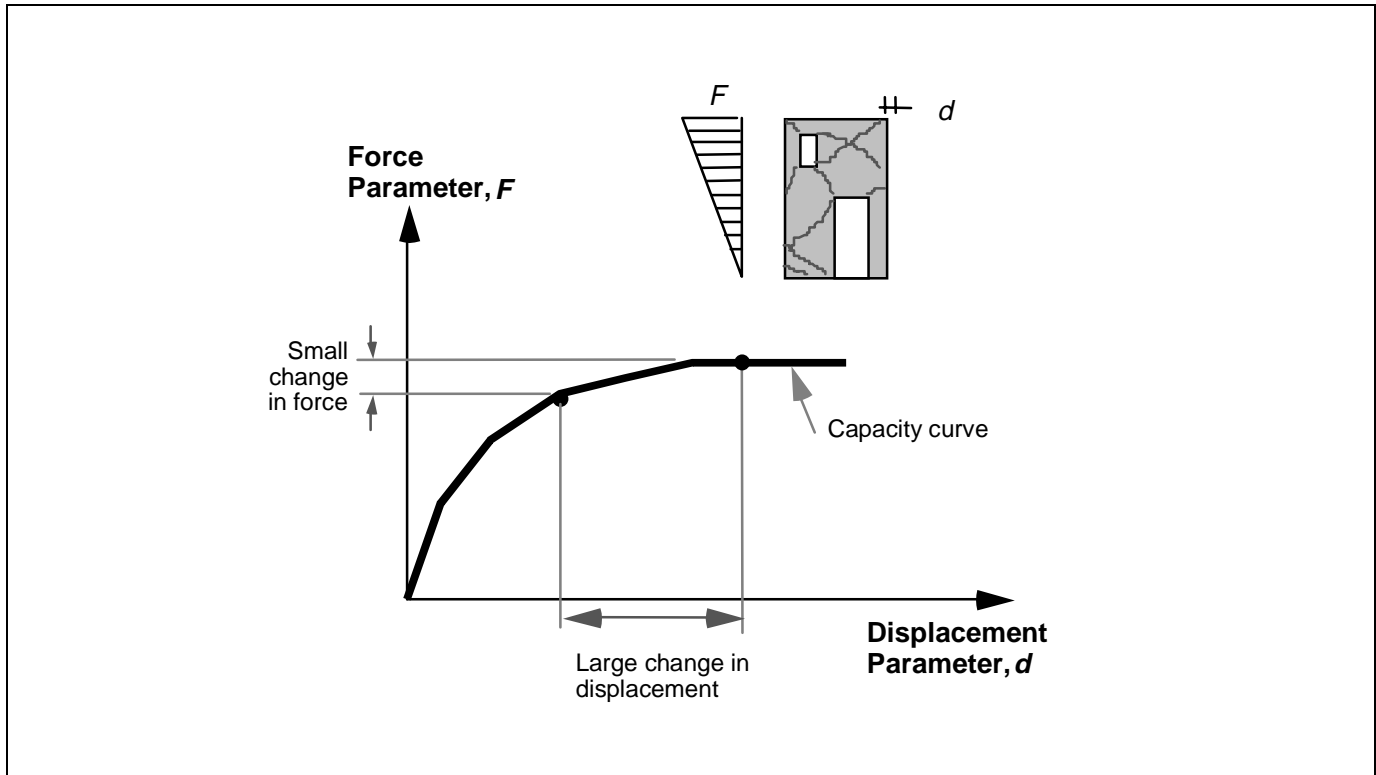
Figure 2-1 Sensitivity of displacement to changes in force

The key to realistic evaluation of the effects of earthquake damage on performance is a methodology that focuses on displacements rather than forces.

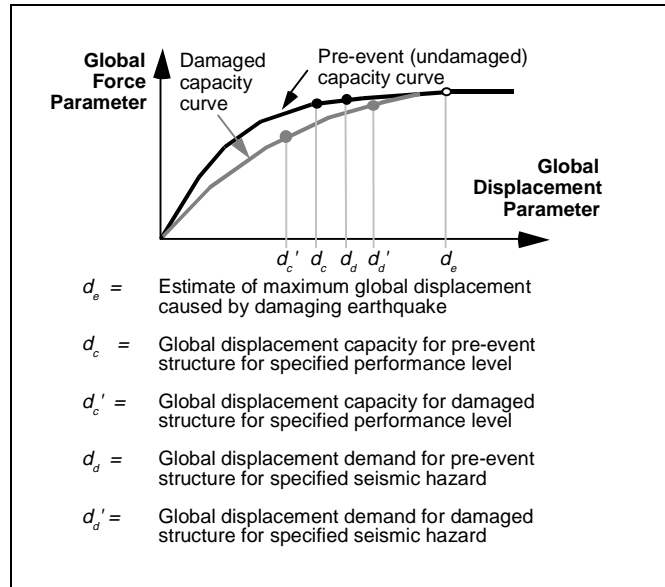
Figure 3-1 Capacity curves from nonlinear static procedures.

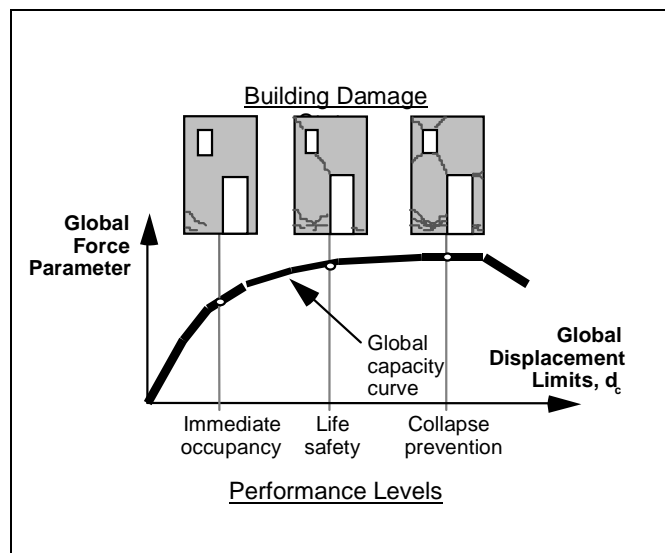
Figure 3-2 Global displacement capacities, d_c , for various performance levels

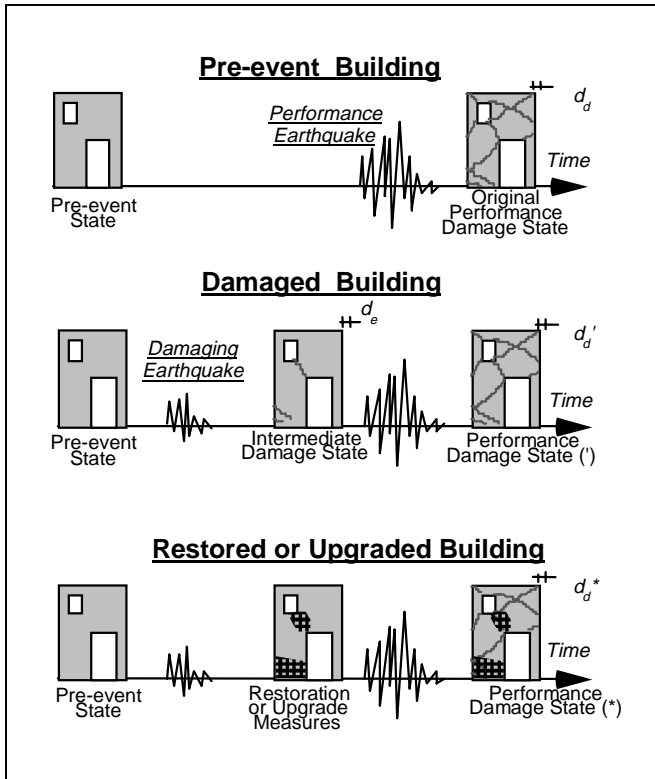
Figure 3-3 Global displacement demand for undamaged, damaged, and restored/upgraded conditions

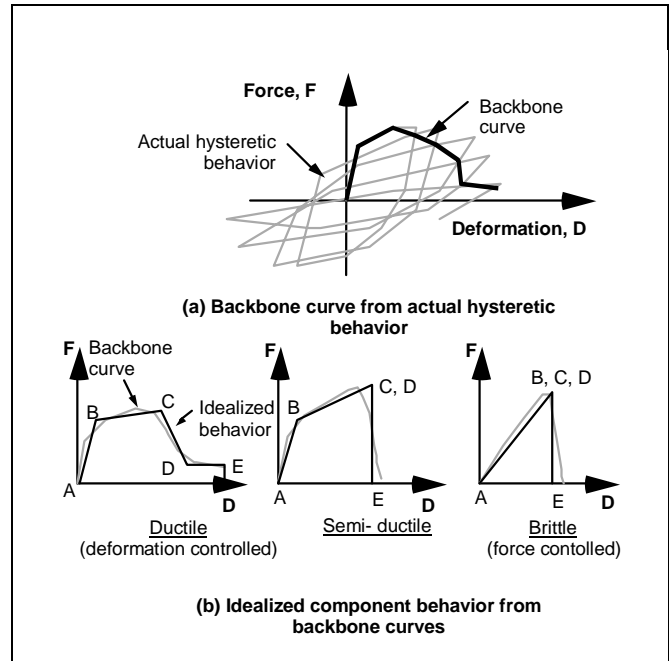
Figure 3-4 Structural component force-deformation characteristics

conditions (Figure 3-4). For a given global displacement of a structure subjected to a given lateral load pattern, there is an associated deformation for each of the structural components of the building. Since inelastic deformation indicates component damage, then the maximum global displacement, d_d , to occur during an earthquake represents a structural damage state for the building in terms of inelastic deformations for each of its components. The capacity of a given structure for a given performance level is represented by the maximum global displacement, d_c , at which the damage is on the verge of exceeding the limit for the specific performance level. For example, the collapse-prevention capacity of a building might be the roof displacement at which the associated damage would result in one or more of the column components being in danger of imminent collapse.

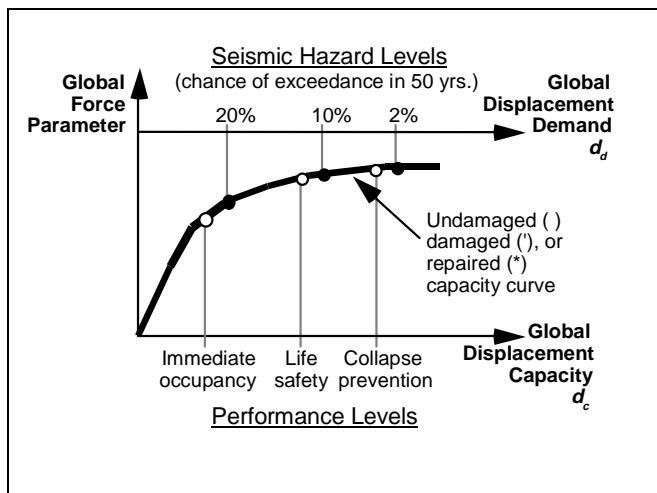
Figure 3-5 Global displacement demands and capacities

displacement demands for various levels of seismic hazard as shown in Figure 3-5. These may be generated using nonlinear static procedures according to the recommendations in FEMA 306, in conjunction with the appropriate capacity curve. In Figure 3-5 these are plotted on the upper horizontal axis noting their chance of exceedance in 50 years. Component acceptability criteria in conjunction with capacity curves also can be

used to define global displacement limits for various performance levels (e.g., immediate occupancy, life safety, collapse prevention). These are shown in Figure 3-5 along the lower horizontal axis. The combined plot provides a complete picture of the risks associated with the particular repair alternative.

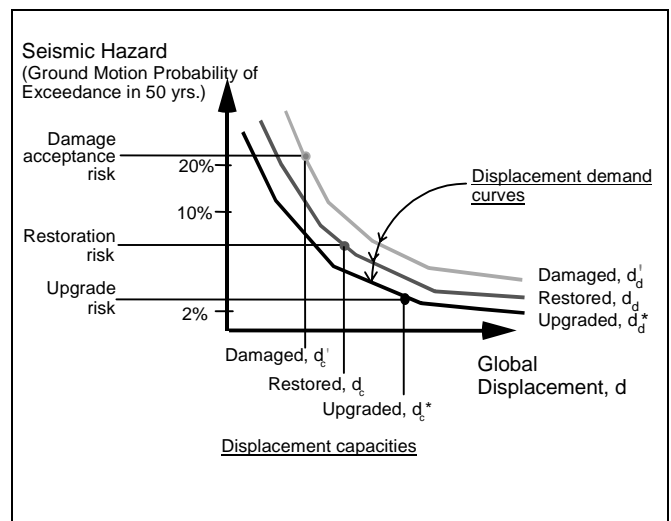
Figure 3-6 Risk associated with damage acceptance, restoration, and upgrade for a specific performance objective

Global displacement demand for various repair alternatives can also be plotted versus a risk parameter as shown in Figure 3-6. The intersection of a global displacement capacity value, for a selected performance level, with the corresponding displacement demand curve allows an estimate of the risk that the performance level would be exceeded for a given repair alternative. Doing this for several repair alternatives, as

shown in Figure 3-6, provides a comparison of the risks associated with each alternative for the selected performance level. For example, suppose that the performance level of interest is life safety. Figure 3-6 illustrates that the chance that the global displacement demand would exceed the life safety capacity of the damaged structure is slightly higher than 20% in fifty years. Restoration of the structure to its pre-event condition would reduce the life safety risk to less than 10%. The upgrade could reduce risk to just above 2% or approximately ten times less than the damaged structure in this illustration.

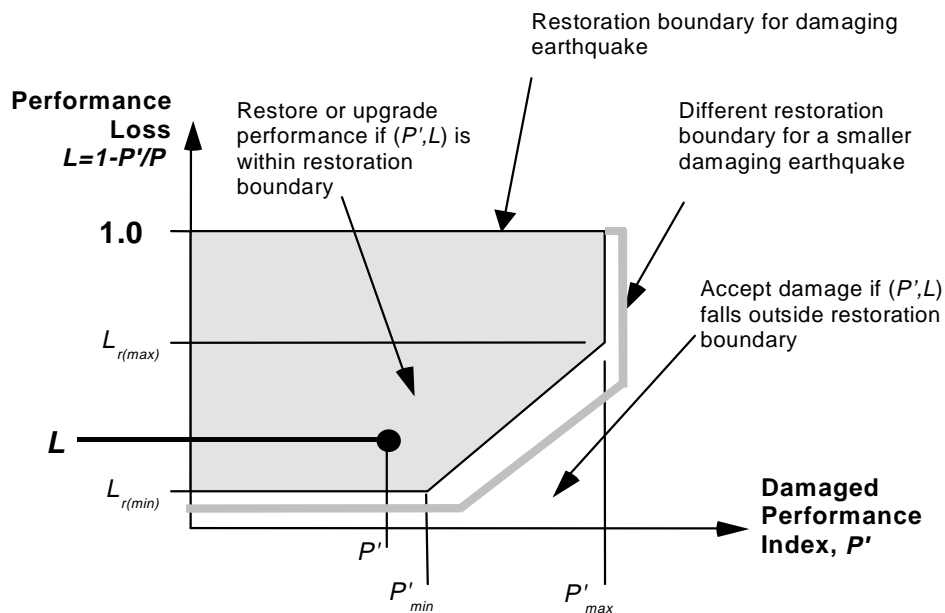
a) Relationship between acceptance of damage versus repair or upgrade

Figure 3-7 Thresholds and performance limits for restoration and upgrade of earthquake-damaged buildings

performance index must be greater than P'_{max} ($P' > P'_{max}$) if damage is to be acceptable regardless of the loss. If the damaged performance index (P', L) is within the restoration boundary, then either restoration or upgrading is required.

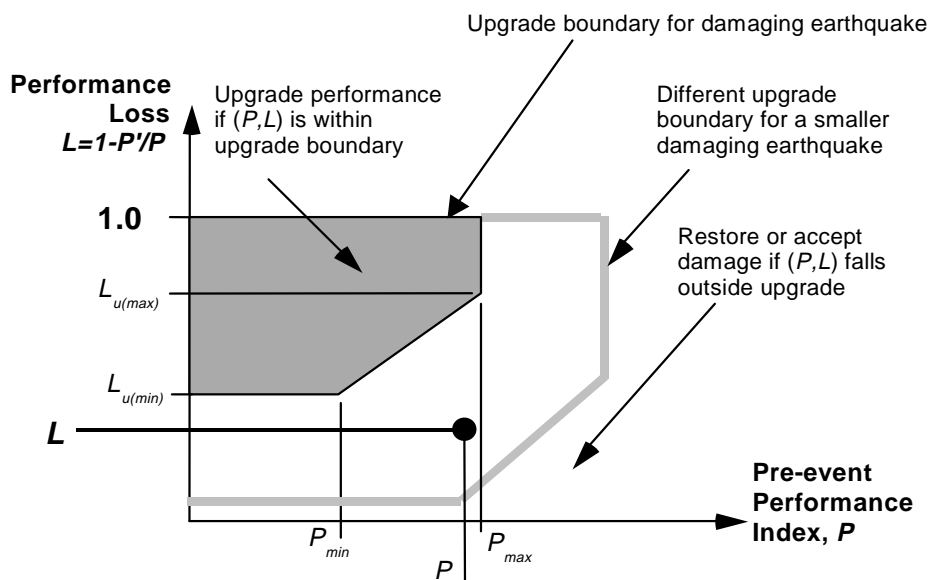
b) Relationship between acceptance of damage or restoration versus upgrade

The parameters affecting the decision between upgrade or restoration are illustrated in Figure 3-7b. The decision between upgrade or restoration is controlled by the loss (L) and the pre-event performance index (P). The upgrade boundary is delineated similarly to the restoration boundary using the parameters in Table 3-2.
